TOWNSHIP 16 SOUTH, RANGE 8 EAST, SALT LAKE MERIDIAN
DEPENDENT RESURVEY OF WEST RANGE LINE AND SUBDIVISION OF SECTION 18

RECORD OF SURVEY

PRICE RANGER DISTRICT EMERY COUNTY STATE OF UTAH

U.S. DEPARTMENT OF AGRICULTURE
FOREST SERVICE - REGION 4
MANT-LA SAL NATIONAL FOREST
599 WEST PRICE RIVER DRIVE, PRICE, UTAH 84501
435.837.2617 - 435.637.4940 FAX - www.fs.usda.gov/mantlasal

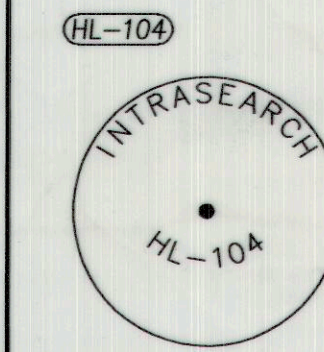
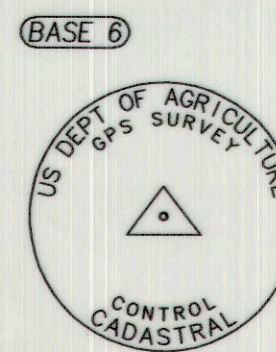
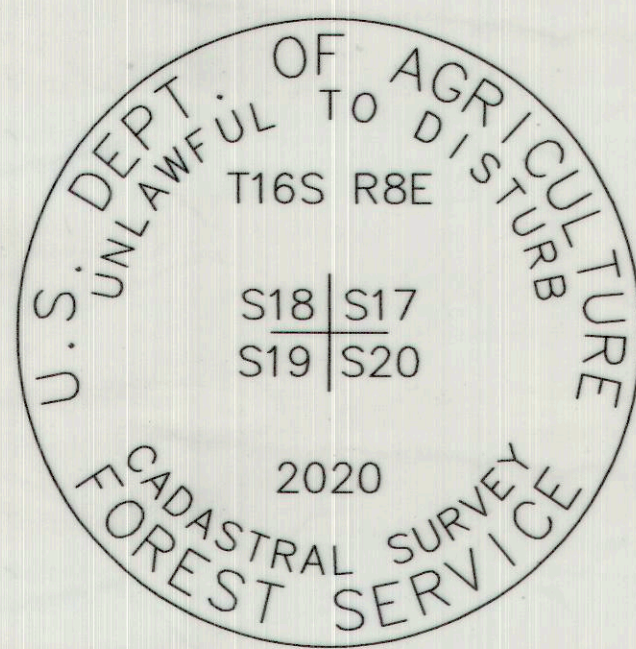
TYPICAL CORNER MONUMENT CAP MARKINGS

THIS SHOWS AN ACTUAL-SIZE DEPICTION OF THE TYPICAL USFS 3-1/4" CAP (WITH SAMPLE MARKINGS) FOR THE BOUNDARY CORNERS SET PER THIS SURVEY. THE MARKINGS AROUND THE EXTERIOR OF THE CAPS ARE THE SAME ON ALL MONUMENTS SET PER THIS SURVEY. THESE CAPS WERE SET ON A 2-1/2" DIAMETER, 30" LONG ALUMINUM POST WITH OPEN FLARED END. A PLASTIC ENCASED 1" DIAMETER MAGNET IS PLACED AT THE BOTTOM OF THE MONUMENT TO AID IN FUTURE RECOVERY. SOME CORNER MONUMENTS UTILIZE A 3/4" DIAMETER, 24" LONG ALUMINUM RODS. ALL MONUMENTS WERE SET WITH THE TOP OF THE CAP ORIENTED NORTH SUCH THAT IT IS RIGHT-SIDE UP TO A PERSON STANDING SOUTH OF THE MONUMENT FACING NORTH. THE ORIGINAL MONUMENT, IF ANY, WAS BURIED OR PLACED ALONGSIDE THE NEW MONUMENT. USFS PROPERTY BOUNDARY (54-2) AND LAND SURVEY MONUMENT (54-9) DECALS WERE PLACED ON A "U" CHANNEL ALUMINUM POST NEAR EACH MONUMENT. IN EACH OF THE MONUMENT DESCRIPTION BLOCKS IS THE GEOGRAPHIC COORDINATE DATA BASE (GCDB) POINT NUMBER, A DEPICTION OF THE CAP MARKINGS SPECIFIC TO EACH CORNER, A PARAGRAPH DESCRIBING WHAT WAS FOUND, IF ANYTHING, THE DISTANCE AND DIRECTION OF ACCESSORIES, AND ANY OTHER INFORMATION PERTINENT IN UNDERSTANDING AND FOLLOWING THIS SURVEY.
